WORKPLACE SAFETY NOTICE (WSN)

1 10916			Reference Number 2022/WSN/01
Approved by:	Issue date:	Expiry date:	Revision No:
Chief Inspector	1 March 2022	None	O

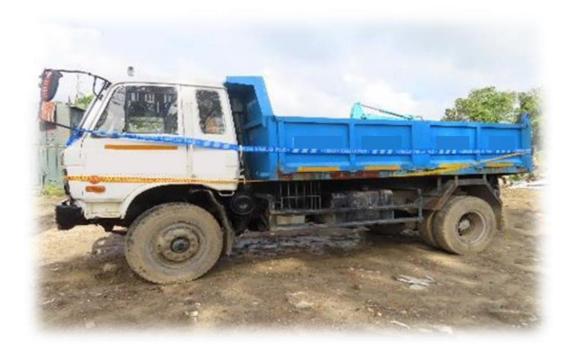
On 12th January 2022, a worker was pinned between the battery steel frame cover and the angle iron guard rail underneath the dumper bucket of a Dump Truck while he was trying to fix the truck battery. The worker died at the scene.

- a) Always ensure that the raised dumper bucket is adequately supported prior to working under it.
- b) Do not rely on the truck's hydraulic system to hold the dumper bucket up while working under it.

- c) **Engage** the dumper-bucket lock bars before performing tasks under a raised dumper-bucket to ensure support is permanently attached and to prevent accidental lowering or sudden drop of the dumper-bucket body. 'Homemade' arrangements are **not advised** as means of support.
